INTRODUCTION

In 2018, the Oyster Recovery Partnership (ORP) was contracted by the Maryland Department of Natural Resources (DNR) to plant spat-on-shell (SOS) on selected oyster reefs in the Severn River sanctuary. To enhance the project, ORP and the Severn River Association (SRA) created a Build-a-Reef campaign designed to improve public awareness and expand the capacity of the DNR project through additional fundraising. The selected reefs were part of an approximately 13-acre complex constructed by the U.S. Army Corps of Engineers (USACE) in 2009, using a combination of alternate substrate materials including stone/granite, concrete, and steel slag. Some reefs were topped with an oyster shell veneer. The reefs were constructed to enhance four historic Yates oyster bars: Traces Hollow, Peach Orchard, Weems Upper, and Wade located between the U.S. 50 and Route 450 bridges (Figure 1). Some reefs within the USACE reef complex have received SOS deployments since construction in 2009 (Table 1).

2019 MONITORING

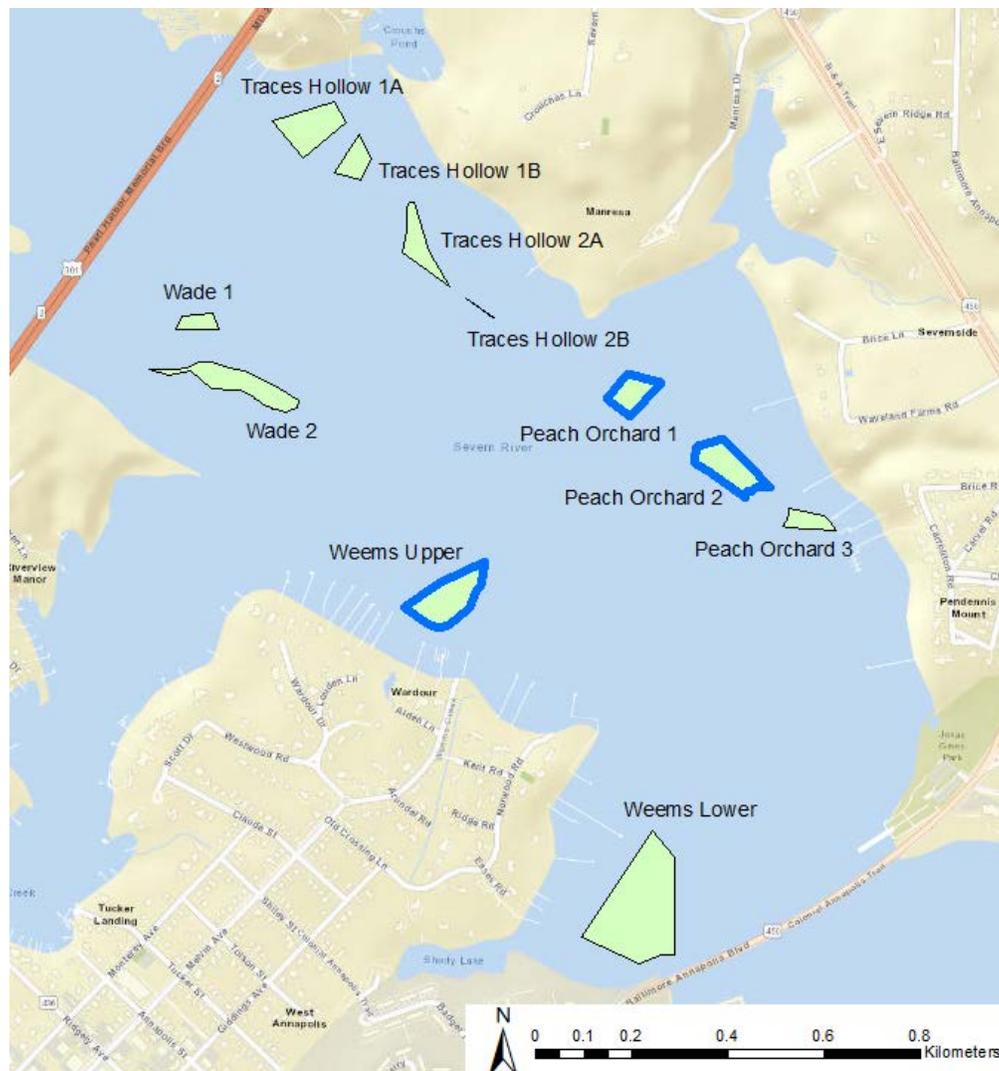
Figure 1. Reefs constructed by USACE in 2009 in the Severn River. Individual reefs have been planted with spat on shell since 2010. Reefs outlined in blue (Upper Weems, Peach Orchard 1, and Peach Orchard 2) were planted during summer 2018.

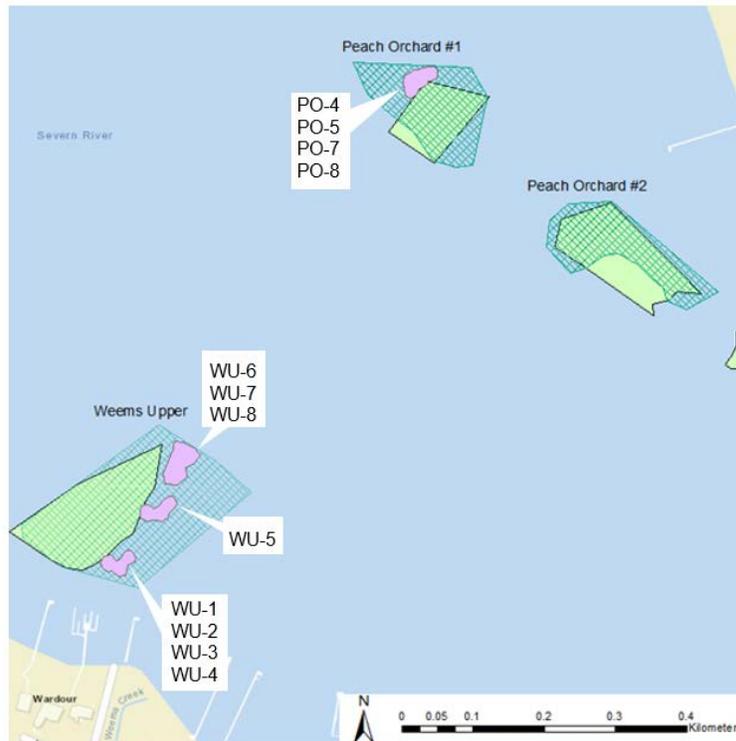
Figure 2. Oyster reef sites sampled in the Severn River by ORP in April 2019. Purple polygons denote locations where multiple patent tong samples were collected to assess the status of 2018 spat-on-shell plantings. Hatched polygons show the extent of SOS plantings over top of USACE constructed reefs: Weems Upper, Peach Orchard 1, and Peach Orchard 2.

Three of the constructed reefs were chosen for SOS enhancement in 2018. These sites were selected based on historic plantings and preference by the DNR. Bathymetric data provided by the NOAA Chesapeake Bay Office and NOAA charts were used to delineate areas within each reef where SOS was deployed (Figure 2). A total of 10.87 acres received 45.14 million spat-on-shell in the Severn River in July and August (Table 2).

Samples sites, as shown by purple polygons in Figure 2, were chosen in the fringing areas around the alternative substrate reefs where patent tongs could be used. The *F/V Baby Boy* was contracted to conduct a patent tong survey at Upper Weems and Peach Orchard bars on the morning of April 2, 2019. The dimensions of the patent tong gear were 1.23m x 1.52m (1.87 m²).

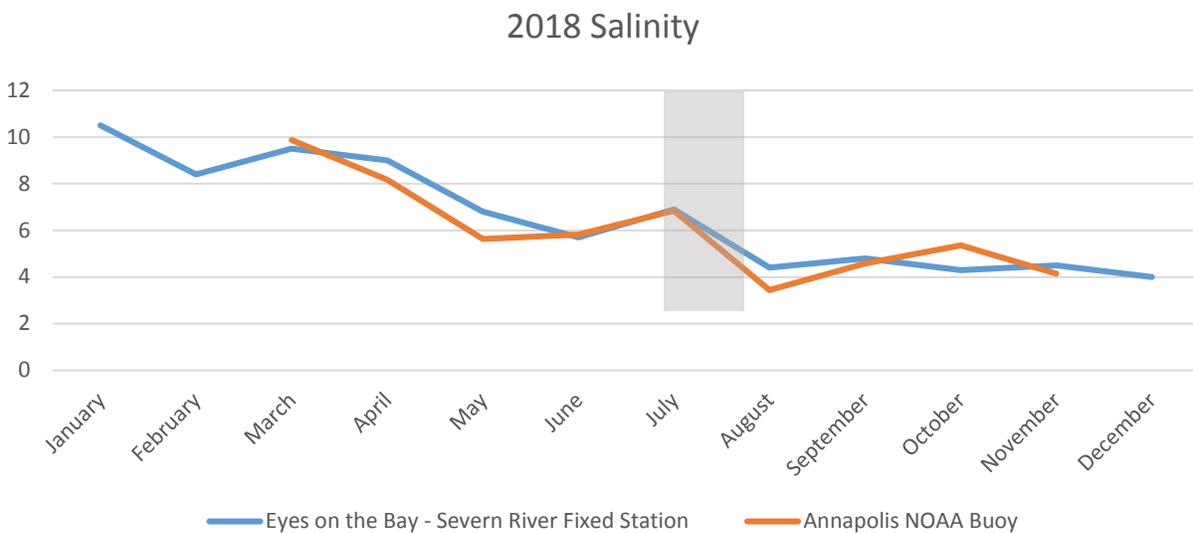
Figure 3. Average monthly salinity for two water quality stations near the restored reef sites. Severn River fixed station is located just north of the Route 50 bridge. Annapolis buoy is located at the mouth of the Severn River. Gray shaded region indicates when SOS was planted between July 23 and August 14, 2018.

ORP staff were concerned that low salinity caused by heavy rainfalls experienced in 2018 would have negative impacts on the spat planted in Severn River (Figure 3). The results were quite encouraging, as live spat from the 2018 planting and live large oysters were observed at both sites (Figures 4 and 5; Table 3). Total observed mortality was between 10-15% over most of the restored areas. At many of the sampling locations, the primary substrate types were loose shell, mud, and living oysters. On Peach Orchard 1 bar, the average shell height of spat measured was 18mm, while the average spat measured on Weems Upper was slightly larger at 18.9mm (Figure 6). Some dead spat were observed, but the majority of observed spat were alive (Figure 7). On both sites, the average size of measured spat boxes (dead oysters with articulated valves) was 30.7mm. Spat mortality ranged from 5-20% over the sampling locations (Table 3).

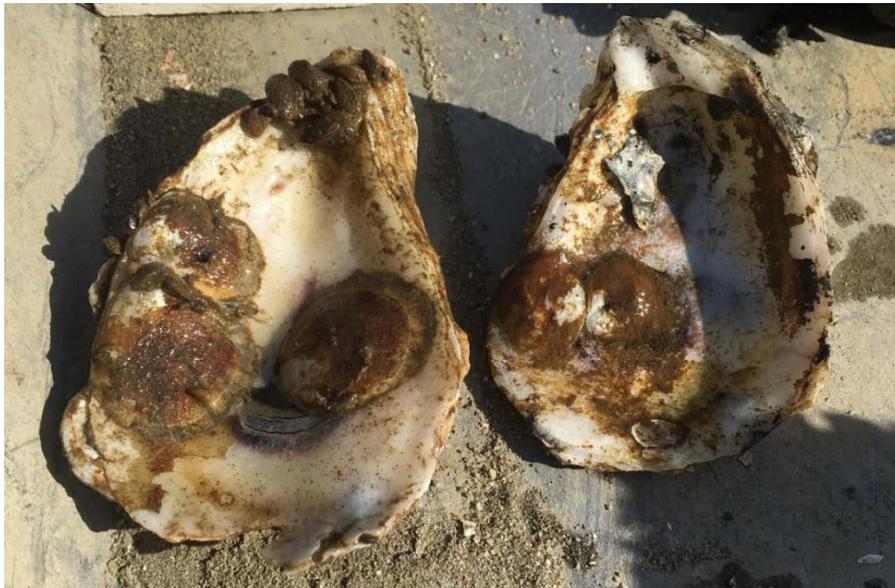
Figure 4. Live spat observed on cultch shell sampled with patent tongs on Weems Upper bar, April 2, 2019.

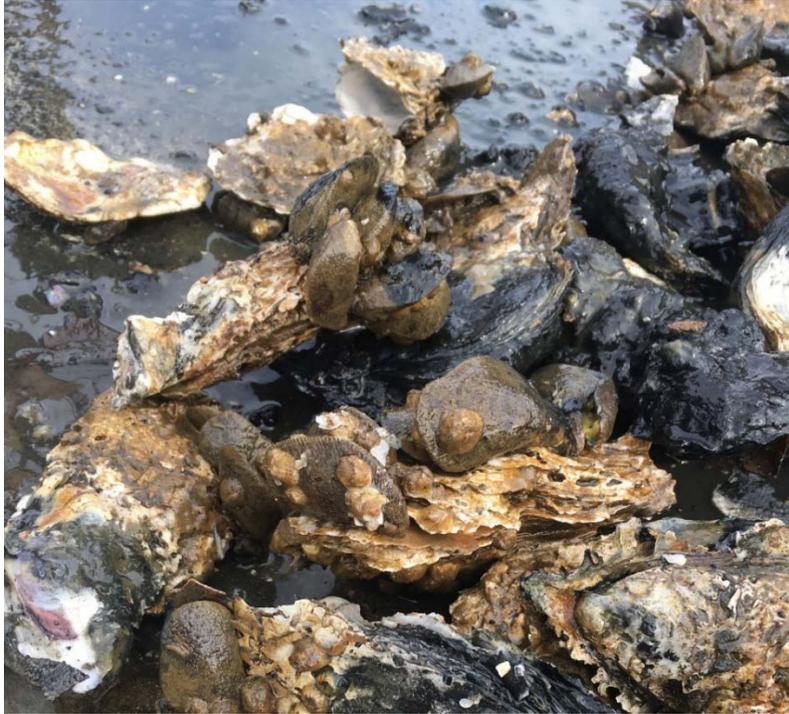
Figure 5. Larger live oysters collected with patent tongs, April 2, 2019.

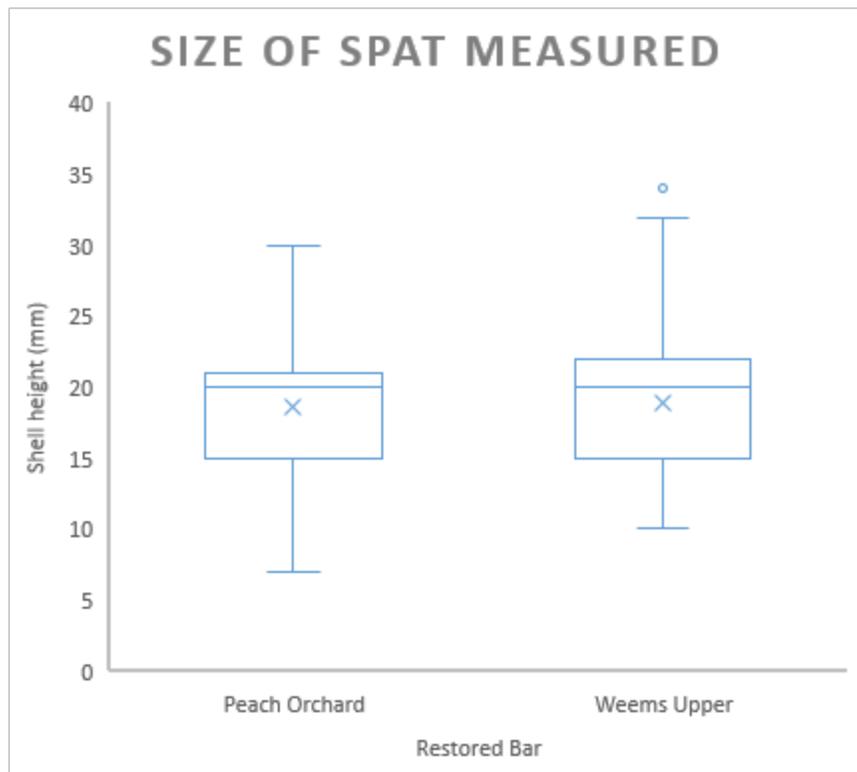
Figure 6. Boxplot of average size of spat measured on restored reefs in Severn River.

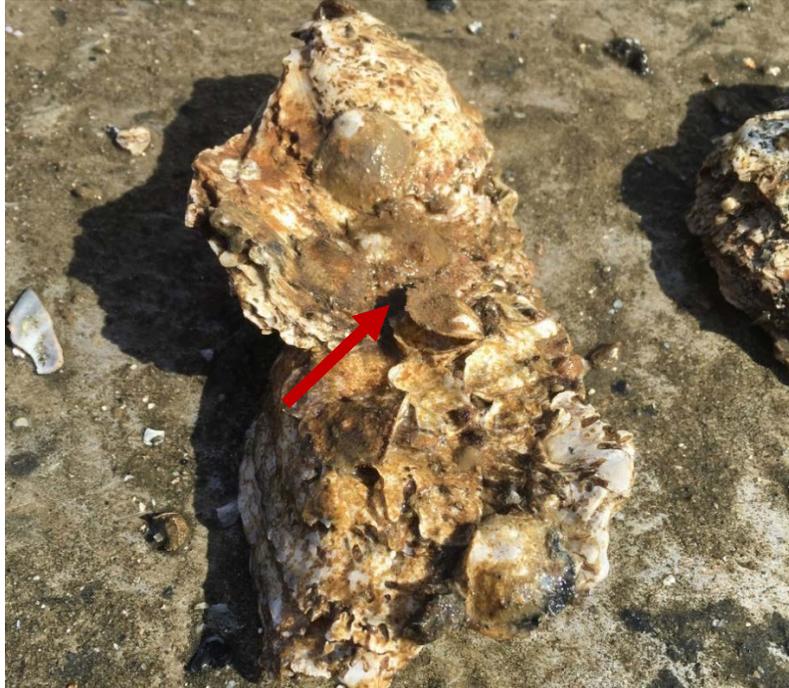
Figure 7. Clump of oysters collected with patent tongs on April 2, 2019. Arrow pointing to dead, gaping spat.

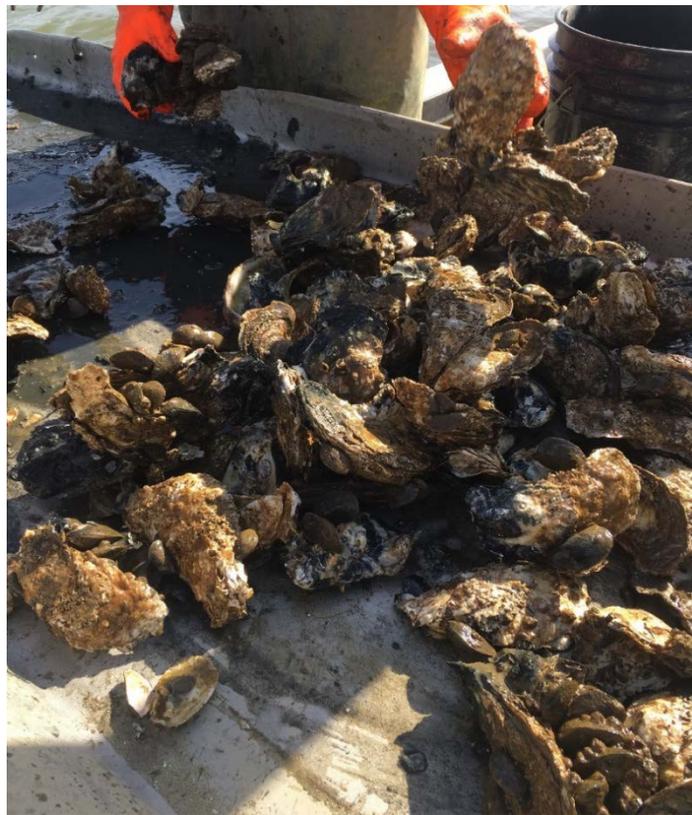
While the main purpose of the survey was to assess the status of spat planted in 2018, the patent tong survey also revealed the presence of large, older oysters; the largest measured was 150 mm. These individuals were likely from plantings that took place in 2010 and 2013. Staff also observed multiple clumps of five or more live oysters, growing upright from the benthos (Figure 9).

Figure 9. Clumps of live oysters collected with patent tongs on April 2, 2019.
